PRELIMINARY SITE INVESTIGATION

PROPOSED SOLUTIONS

Allsteel Inc. Allsteel Drive Aurora, IL 60507

Prepared by: Dennis M. Ruetten, P.E.
Supervisor/Facility Schedule
and Control

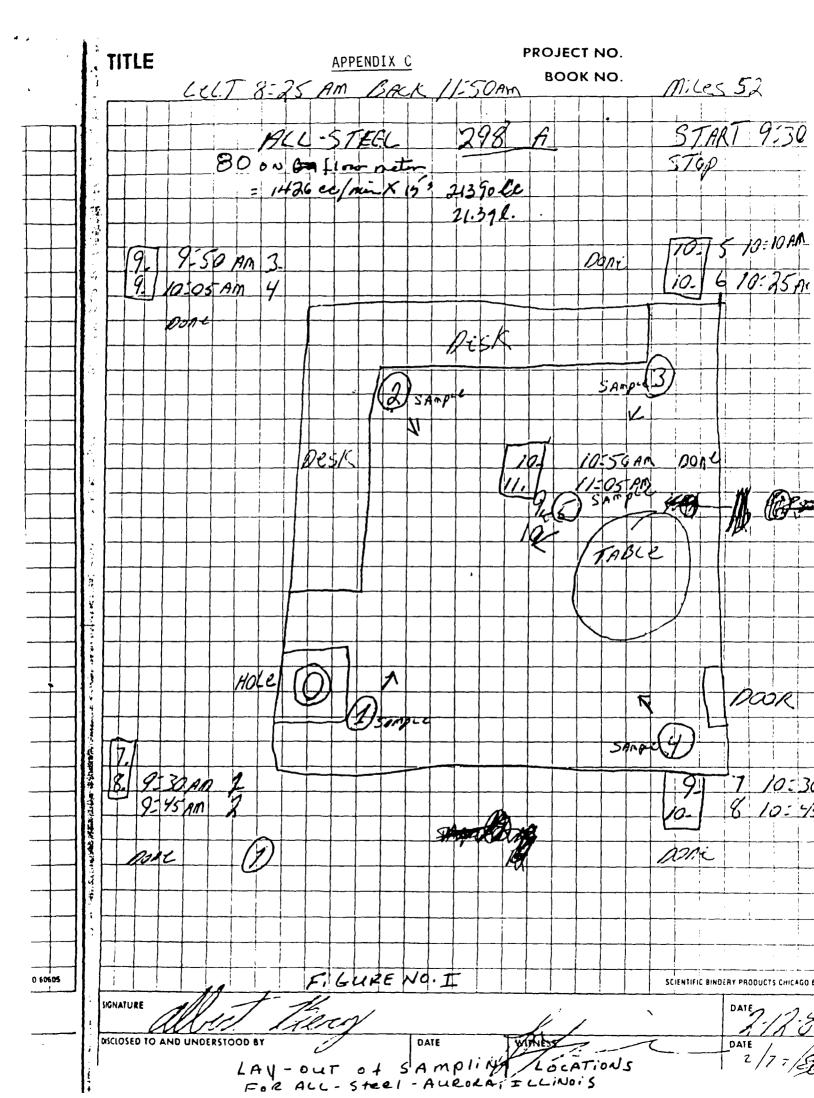
Figure No. 1 shows the location of the sampling sites for the office area. At least, 10 liters of air was sampled at each sampling point.
